Surface performances of PVD ZrN coatings in biological environments

C. Ramoul, N. E. Beliardouh, R. Bahi, C. Nouveau, A. Djahoudi & Michael J. Walock

Zirconium nitride (ZrN) thin films were deposited by reactive RF magnetron sputtering on Ti-6Al-4V and Si (100) substrates for potential use in biomedical applications. The tribological behaviour was evaluated against bovine bone in dry condition using a pin-on-disc apparatus. Abrasion is the primary wear mechanism observed in ZrN/bone contact. The corrosion properties were determined through two electrochemical techniques: potentiodynamic polarization and electrochemical impedance spectroscopy. The coatings with reduced oxygen content provided: (i) good resistance against corrosion when exposed to physiological solution and (ii) better anti-bioadhesion against *Staphylococcus aureus* bacteria.

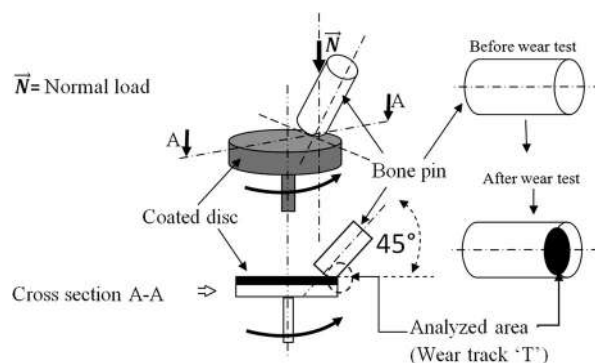
When it is impossible to make a ball geometry, e.g. from organic matter of animal origin (bone, cartilage, etc.), the pin-on-disk configuration provided by [®]CSM Instrument tribometer is perfectly adapted for this case (Figure 1). The pin holder is positioned at 45° ; this allows to make several tests with one pin. The tribological test parameters are listed in Table 2.

Figure 1. Schematic of the pin-on-disc tests.

Figure 6 (a–d) shows micrographs of the bone pin wear scars. It appears that the edges of the bone pin (see Figure 1; *analyzed area (Wear track 'T')*) become larger after acting as counterparts against ZrN-coated discs. Wear scars also reveal deformation of the Haversian system, lacunae (crevasses indicated by white narrows), isolated wear particles (black narrows) and entrapped particles (ellipse). EDS analyses, carried out at different locations (isolated as well as entrapped

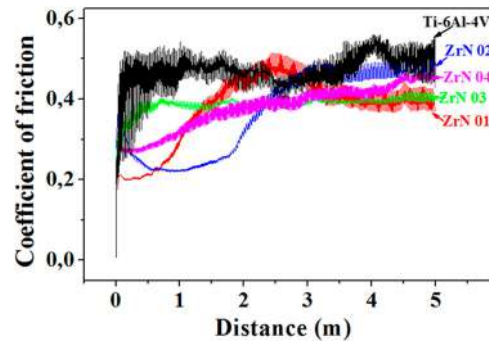
Figure 3 shows the friction coefficient curves of the ZrN films sliding against bovine bone in dry conditions. It shows that the friction coefficients of the four coatings possess similar features, i.e. the friction curves of ZrN films are characterized by two different stages. The first stage represents run-in and ends with a rapid increase of the COF; the second stage was the steady state wear regime.

During dry sliding tests, the following scenario most probably occurs; at the beginning of the wear test, there is a severe material transfer between the coating and the pins, which leads to an increase of the COF. When the steady state is reached, the material transfer is slowly reduced and stabilized after a large percentage of the wear track area is covered with the transferred material. At the steady state, the highest COF value (~ 0.58) was observed for the ZrN-02 coating surface, whereas lower COF values (~ 0.38) were obtained for the other three ZrN coatings (Figure 3). Thus, the COF is fairly high. That is the disadvantage of hard ceramic coatings (ZrN), e.g. their brittleness and relatively high COF. The COF of the uncoated substrate at the

Figure 3. COF of the ZrN coatings sliding against bone counterparts.

steady state was ~ 0.58 . From Figure 3, there is clear evidence that, after 3 m of sliding distance the coatings are destroyed.

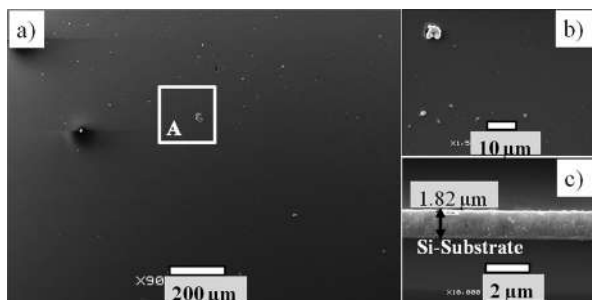
Figure 2 shows SEM images of an as-deposited ZrN coating on a Si substrate. There are some sputtering defects, e.g. pits and droplets, as shown in Figure 2

(a–b). All films have an overall thickness of ~ 1.6 to $1.9 \mu\text{m}$ and exhibit a columnar structure, as shown in Figure 2(c). The surface roughness of the samples is shown in Table 2. No remarkable differences in roughness parameters (R_a , R_q) are observed. The ZrN-01 and ZrN-02 samples have a relatively low oxygen content in comparison to ZrN-03 and ZrN-04.

Figure 2. SEM images of the as-deposited ZrN-01 coating on Si substrate: (a) global view of the surface, (b) magnified image of the region enclosed by the white square (area A) and (c) cross-section image of the same sample.

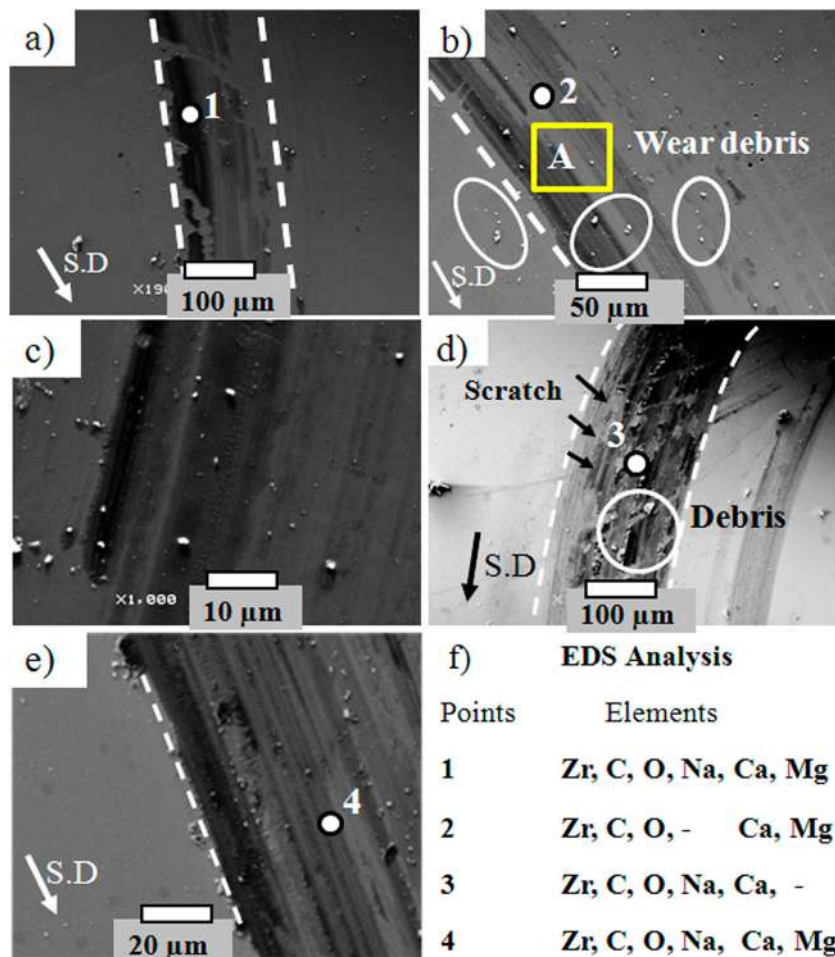
Figure 4 shows the wear tracks of ZrN coatings on Ti-6Al-4V substrates tested against bone pins as counterparts in dry conditions. The primary wear mechanism appears to be abrasion, as shown in Figure 4(a–d). In addition to grooves and scratches parallel to sliding direction, wear debris accumulated in the wear tracks are also observed as deep furrows from trapped particles (Figure 4(c)). The elemental composition of some isolated particles, analysed by EDS, indicates the presence of both bone elements (Na, Mg, Ca, K, etc.) and coating elements (Zr and oxygen) in the adhered film (points 1, 2, 3, 4 in Figure 4(a–e)). So, the wear debris is a mixture of the antagonist pair components. From this, one can conclude that bone adhesion to the disc is the second wear mechanism observed in the ZrN/bone contact pair. SEM analysis also revealed some areas within the wear track where the coating did not appear to be damaged after the wear tests. No plastic deformation was detected in the wear tracks on any of the coatings.

Figure 4. Wear mechanism of ZrN coatings: abrasion (scratches-grooves) and bone adhesion wear; (a) wear track of ZrN-01, (b) wear track of ZrN-02, (c) zoom of the square A, (d) wear track of ZrN-03, (e) wear track of ZrN-04 and (f) EDS analysis results at points 1, 2, 3, 4; (S.D – sliding direction).

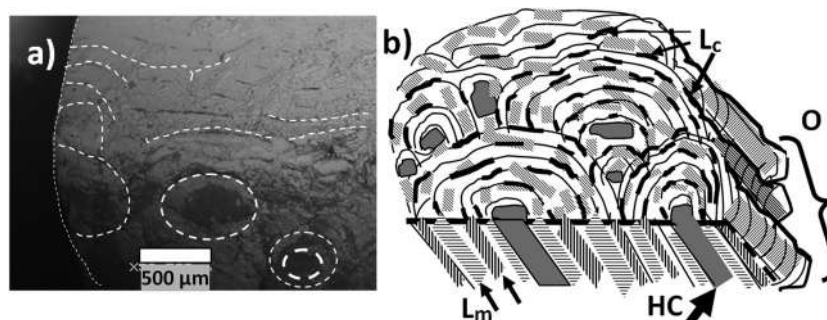
Bone is a heterogeneous and anisotropic material. It has a hierarchically organized structure and is often classified as a ‘composite material’ [6]. At the highest hierarchical level (with feature sizes ~ 1 to 5 mm), there are two types of bone: cortical bone (which is the type used in this study) and trabecular bone. Cortical bone consists of repeating units called Haversian

systems or osteons. [6]. The macrostructure of the bone pin specimen (cortical bone) is shown in Figure 5.

Figure 5. (a) SEM micrograph of a bone pin specimen. (b) A schematic diagram illustrating the macrostructure of cortical bone; O – Osteons (Haversian systems), L_m – concentric lamellae, HC – Haversian canal and L_c – lacunae.

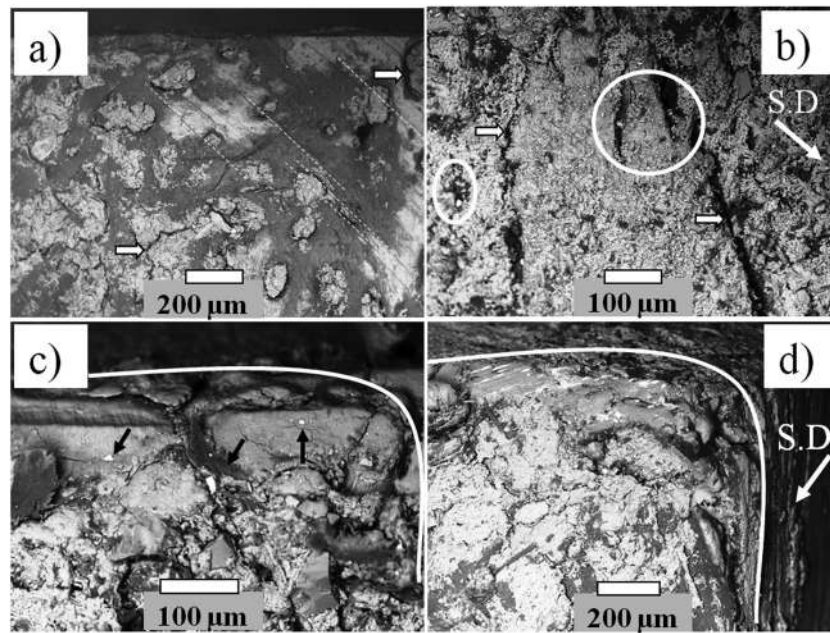
particles) within the wear scars, indicate that a mixture of both the antagonist elements in contact was found. Abrasive wear is the only wear mechanism observed on the bone pins.

When sliding against ZrN-coated discs, segments of the bone pins were initially scraped off by surface asperities along the wear track. This is due to the large difference in mechanical properties between the antagonists in contact. A literature study reveals the average hardness (H) and elastic modulus (E) of cortical bovine bone obtained from nanoindentation in

Figure 6. SEM images of wear scars of bone pins after pin-on-disc tests for: (a) ZrN-01, (b) ZrN-02, (c) ZrN-03 and (d) ZrN-04 (dash lines indicate scratch marks, SD – sliding direction).

transversal direction between 0.647 and 0.892 GPa and 19.8 ± 1.6 GPa, respectively [7]. ZrN coatings hardness and modulus values range from 15 to 34 GPa and 240 to 320 GPa, respectively [8]. As the number of sliding cycles increases, the transferred layer onto ZrN surface becomes brittle and is destroyed through fatigue; the resulting wear debris acts as a third body.

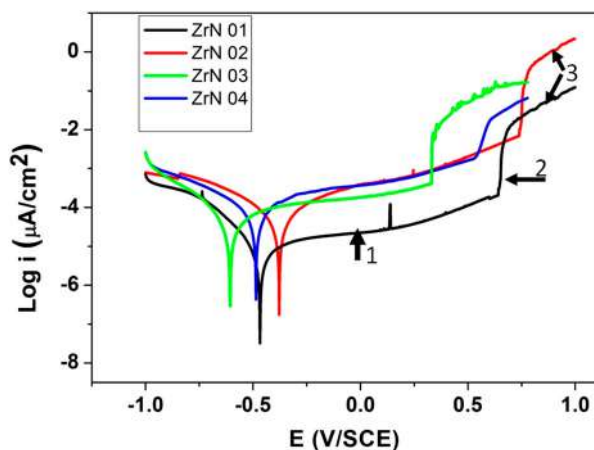
Figure 7(a) shows the potentiodynamic polarization curves (plots of potential vs. log current density) of the ZrN coatings exposed to the PS for 2 h. All specimens form an anodic domain (labelled '1'), which corresponds to the formation of a self-passivating (Zr, N,

Figure 7. Potentiodynamic polarization curves of ZrN coatings in physiological liquid solution.

O) film after being soaked for a period of time. The size of this domain is indicative of the durability of the self-passivating film and the corrosion resistance of each coating. For example, the anodic plateau remained flat from -0.4 up to $+0.65$ V in the case of ZrN-01. The rupture of the passive film occurs in the trans-passivation domain (labelled '2'). In this domain, the current density abruptly increases as the materials start to corrode (labelled '3'). The polarization resistance (R_p) of Tafel curves, which takes into consideration both the corrosion current density and the slopes of polarization curves, can provide a quantitative ranking of coatings resistance to corrosion and can be estimated using the well-known Stern–Geary equation.

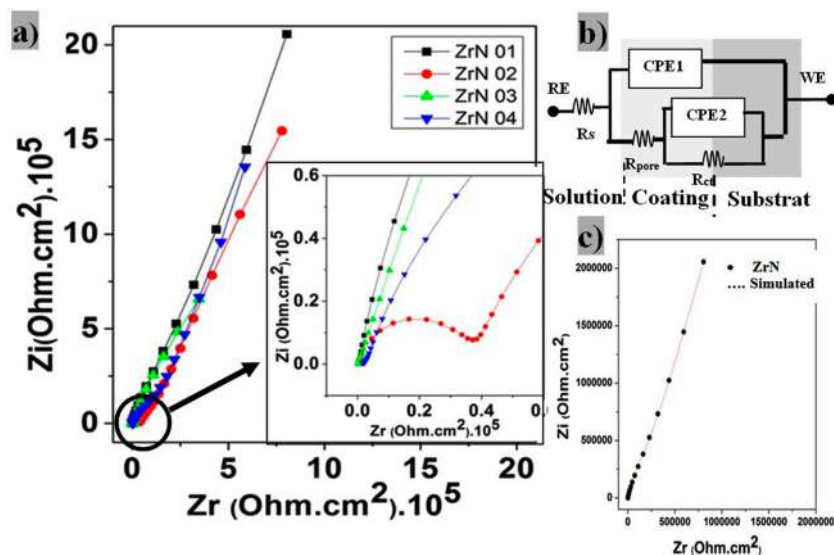
Each sample's impedance was measured after 1 h of immersion in the PS. Nyquist plots of the real and imaginary parts of the impedance are shown in Figure 8(a). The plots show that all tested samples are characterized by two capacitive loops in the high and medium

Figure 8. Electrochemical test results (EIS): (a) Nyquist plots of tested specimen in physiological liquid solution, (b) equivalent circuit model and (c) example of fitting curve (WE = working electrode and RE = reference electrode).

frequency range. By comparing the diameters of the loops in the Nyquist plot, the sample's corrosion properties can be easily evaluated. Larger diameter loops equate to higher corrosion resistance. This analysis supports the previous conclusion: ZrN-01 has the best corrosion resistance of the four tested samples. An equivalent circuit (EC) model, which is shown in Figure 8(b), was selected for quantitative studies. This EC is extensively used in similar situations [9]. Figure 8(c) shows good agreement between the experimental and modelled values. The fitted line was plotted as a dashed line. The fitting errors for each configuration in this study were less than 9%.

In the selected equivalent circuit, R_s represents the electrolyte resistance. The Constant Phase Elements, CPE1 and CPE2, are the double layer capacitance and the coating capacitance respectively. R_{ct} is the charge transfer resistance and R_{pore} represents the pore resistance (and other fails of coating).

The overall corrosion resistance of the coating can be estimated by the sum of all resistances of the circuit model in accordance with the method described by Subramanian et al. [9]. Therefore, using the quantitative data given in Table 4, the ZrN-01 coating presents the highest resistance against corrosion in a physiological liquid solution of the four tested samples, as expected.

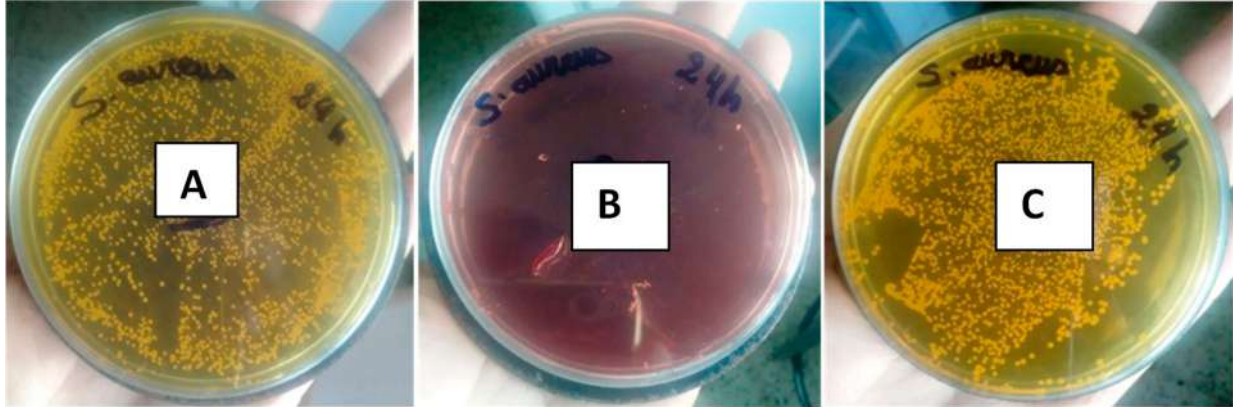
After incubation, the *S. aureus* colonies are clearly visible (Figure 9) and were easily counted. The results indicate that *S. aureus* bacteria were completely killed in specimen B, while the surviving bacterial colonies are 3.2×10^5 (CFU/ml) for specimen A and 5.2×10^5 (CFU/ml) for specimen C. Specimen B and Specimen C have approximately similar surface parameters (i.e. roughness, morphology, etc.) but there is a noticeable difference in the oxygen content of the samples. So, surface morphology effects cannot explain the difference in the biocidal effect of these two specimens (B and C). In addition, it has been reported that a surface roughness $<0.2 \mu\text{m}$ may not affect bacterial adhesion because most bacteria are $>0.2 \mu\text{m}$ [12].

**Figure 9.** *Staphylococcus aureus* colonies grown in sterilized Petri dishes of: (a) specimen A, (b) specimen B and (c) specimen C.
